SKF PRO 08-029US/CA
November 5, 2008
MC: A1,A4,M2,M6

Safety Recall Notice to End Users

NHTSA Recall #08E-064 of SKF BR930361 hub bearing assembly; SKF Recall # PRO 08-029US/CA

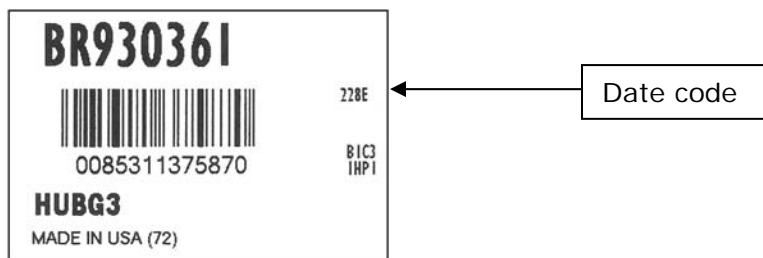
This recall involves SKF part number BR930361 that is identified by the following packaging date codes: 155E, 161E, 170E, 171E, 185E, 213E and 228E. This part was sold exclusively in the aftermarket for use on the vehicle identified. **Important note: Only parts with one of these date codes are covered by this campaign.** The box part number label is shown below.

The date code appears on the upper right hand side of the part number label.

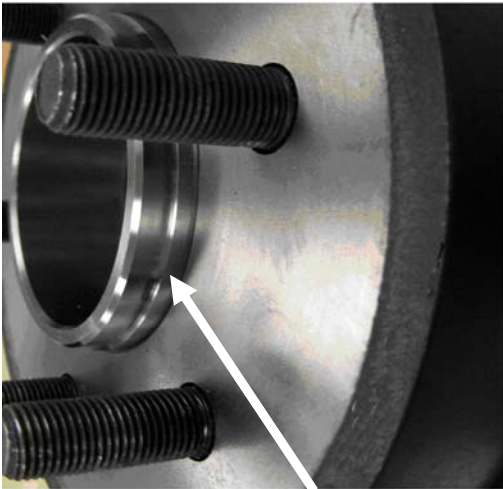
Figure 1
machined

The rotor pilot for the hub bearing assembly was made too long. This results in the wheel to not be seated fully against the hub flange face during mounting. Improper seating of the wheel can result in excessive vibration, brake rotor noise, difficulty removing the wheel after installation and operation of the vehicle, and possibly wheel-end separation during vehicle operation. **Should the wheel-end separation occur, the driver could lose control of the vehicle, possibly resulting in a crash.**

1. Raise and support the vehicle following the manufacturer's guidelines and remove the front wheel.
2. Carefully examine the center brake rotor pilot depth. ***The affected hub bearing assembly will have a noticeable visible step just above where the brake rotor is seated.*** Refer to Figures 1 & 2. Figure 1 illustrates the incorrectly machined hub and brake rotor mounting set up. Figure 2 illustrates the correctly machined hub and brake rotor mounting set up.

Defective

If you have identified a hub bearing assembly that is defective, remove the defective hub assembly and replace it with a non-defective replacement hub assembly using the manufacturers recommended repair procedures. Return the defective hub assembly to the place of purchase for reimbursement as identified above.

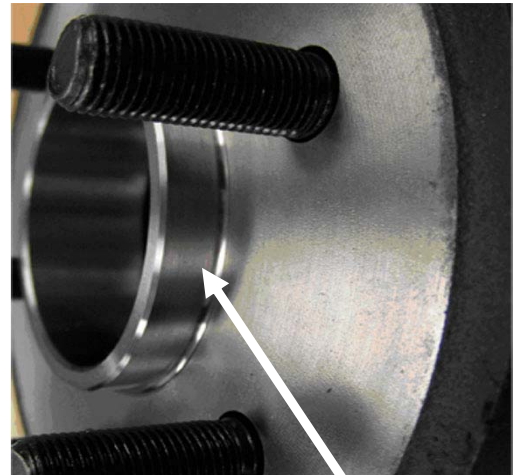
Figure 2

Correctly
